Assessing Coastal Vulnerability and Beach Stability: A Connecticut Case Study

HAZARDS RESEARCH GROUP

BINGHAMTON
UNIVERSITY
STATE UNIVERSITY OF NEW YORK

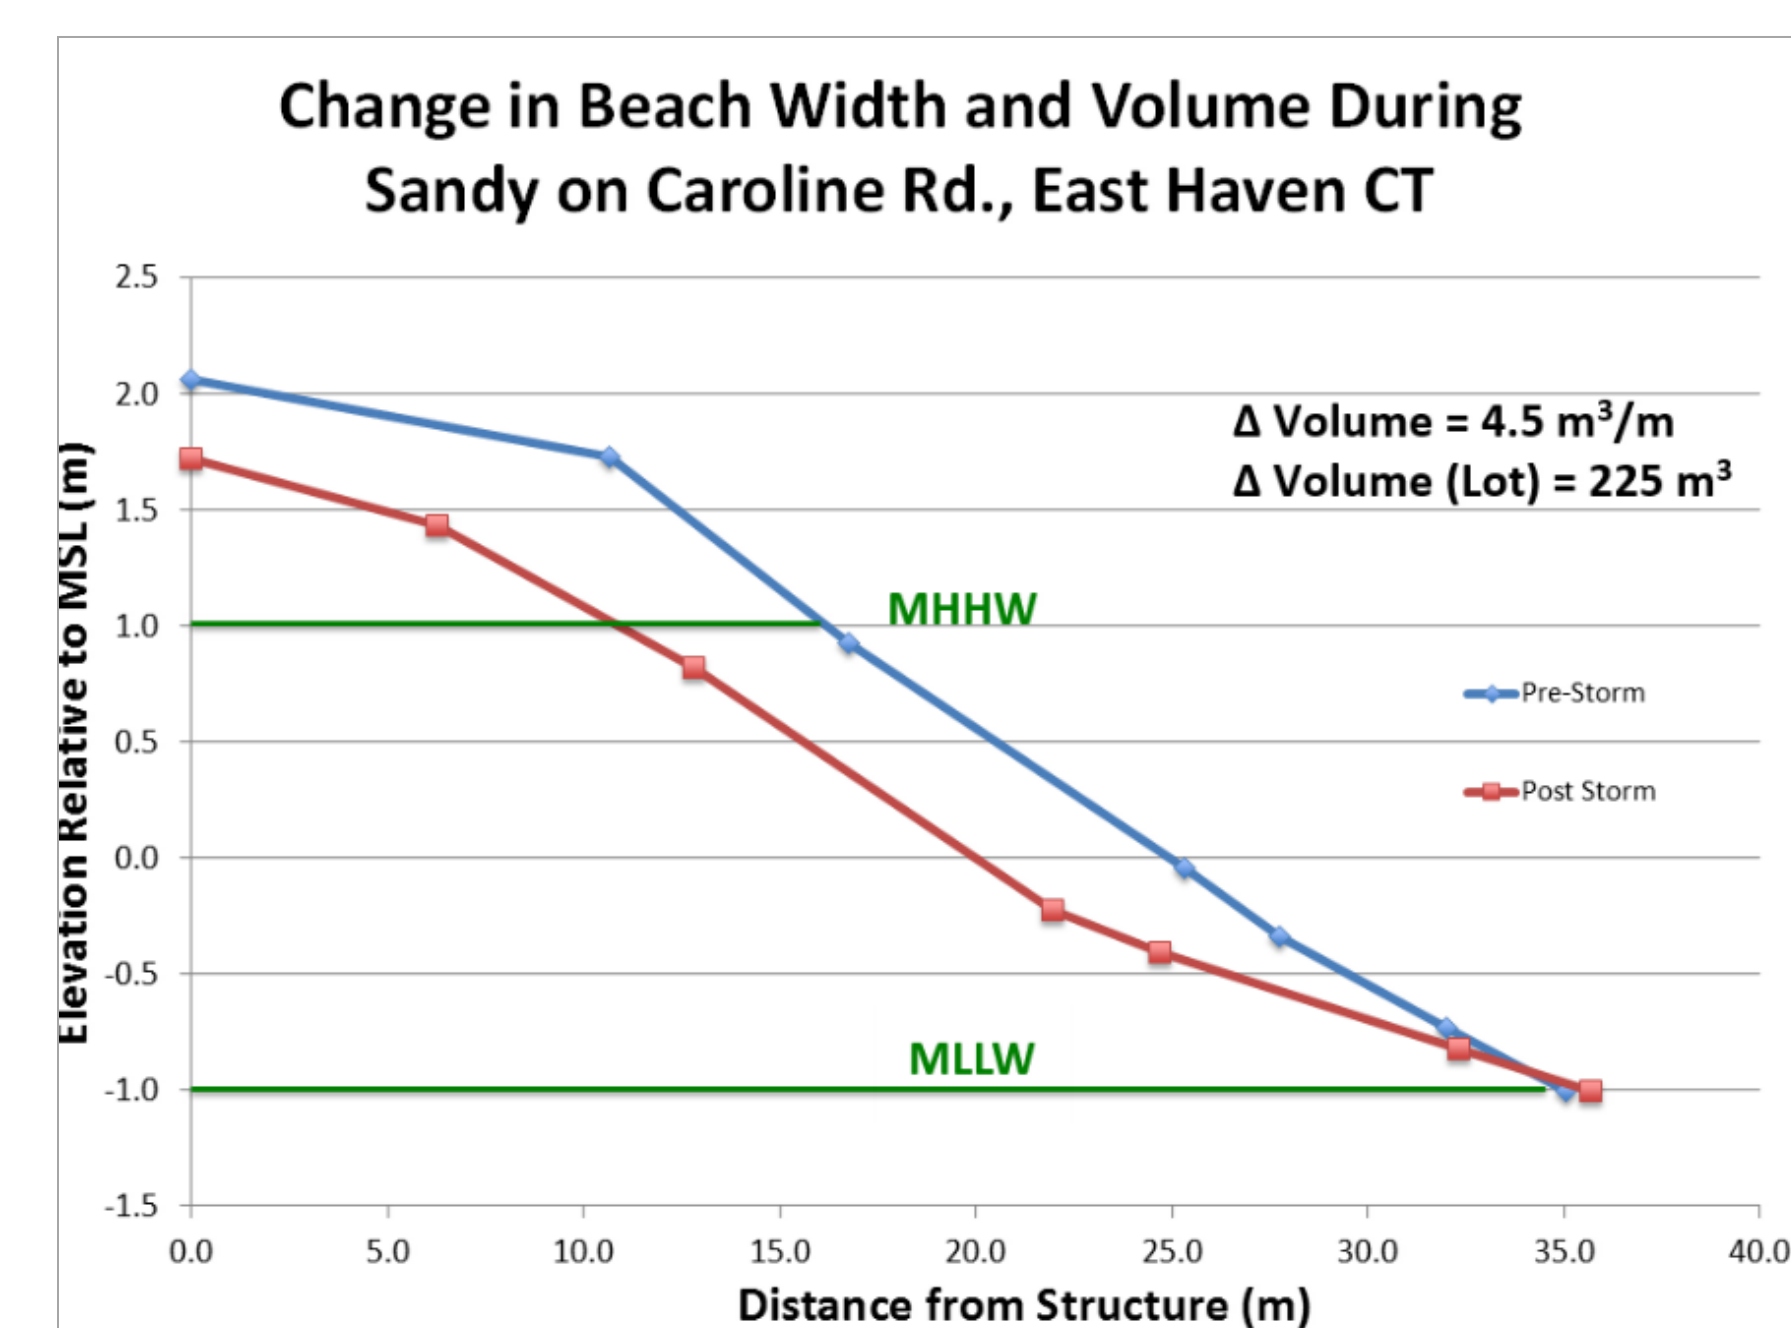
This graph represents the volume of beach width lost due to Superstorm Sandy at a specific profile location.

Topographic elevation, presence of seawalls, and raised structures all influence the severity of wave damage during storms. Data analysis, however, indicated that beach width and height were the primary determinants of the degree of wave damage to coastal structures. Elevation was another notable factor. The data collected has been used to support proposed policy changes that would make it easier to maintain the buffering capacity of local beaches in the face of large storm waves through updated beach nourishment projects and policy.

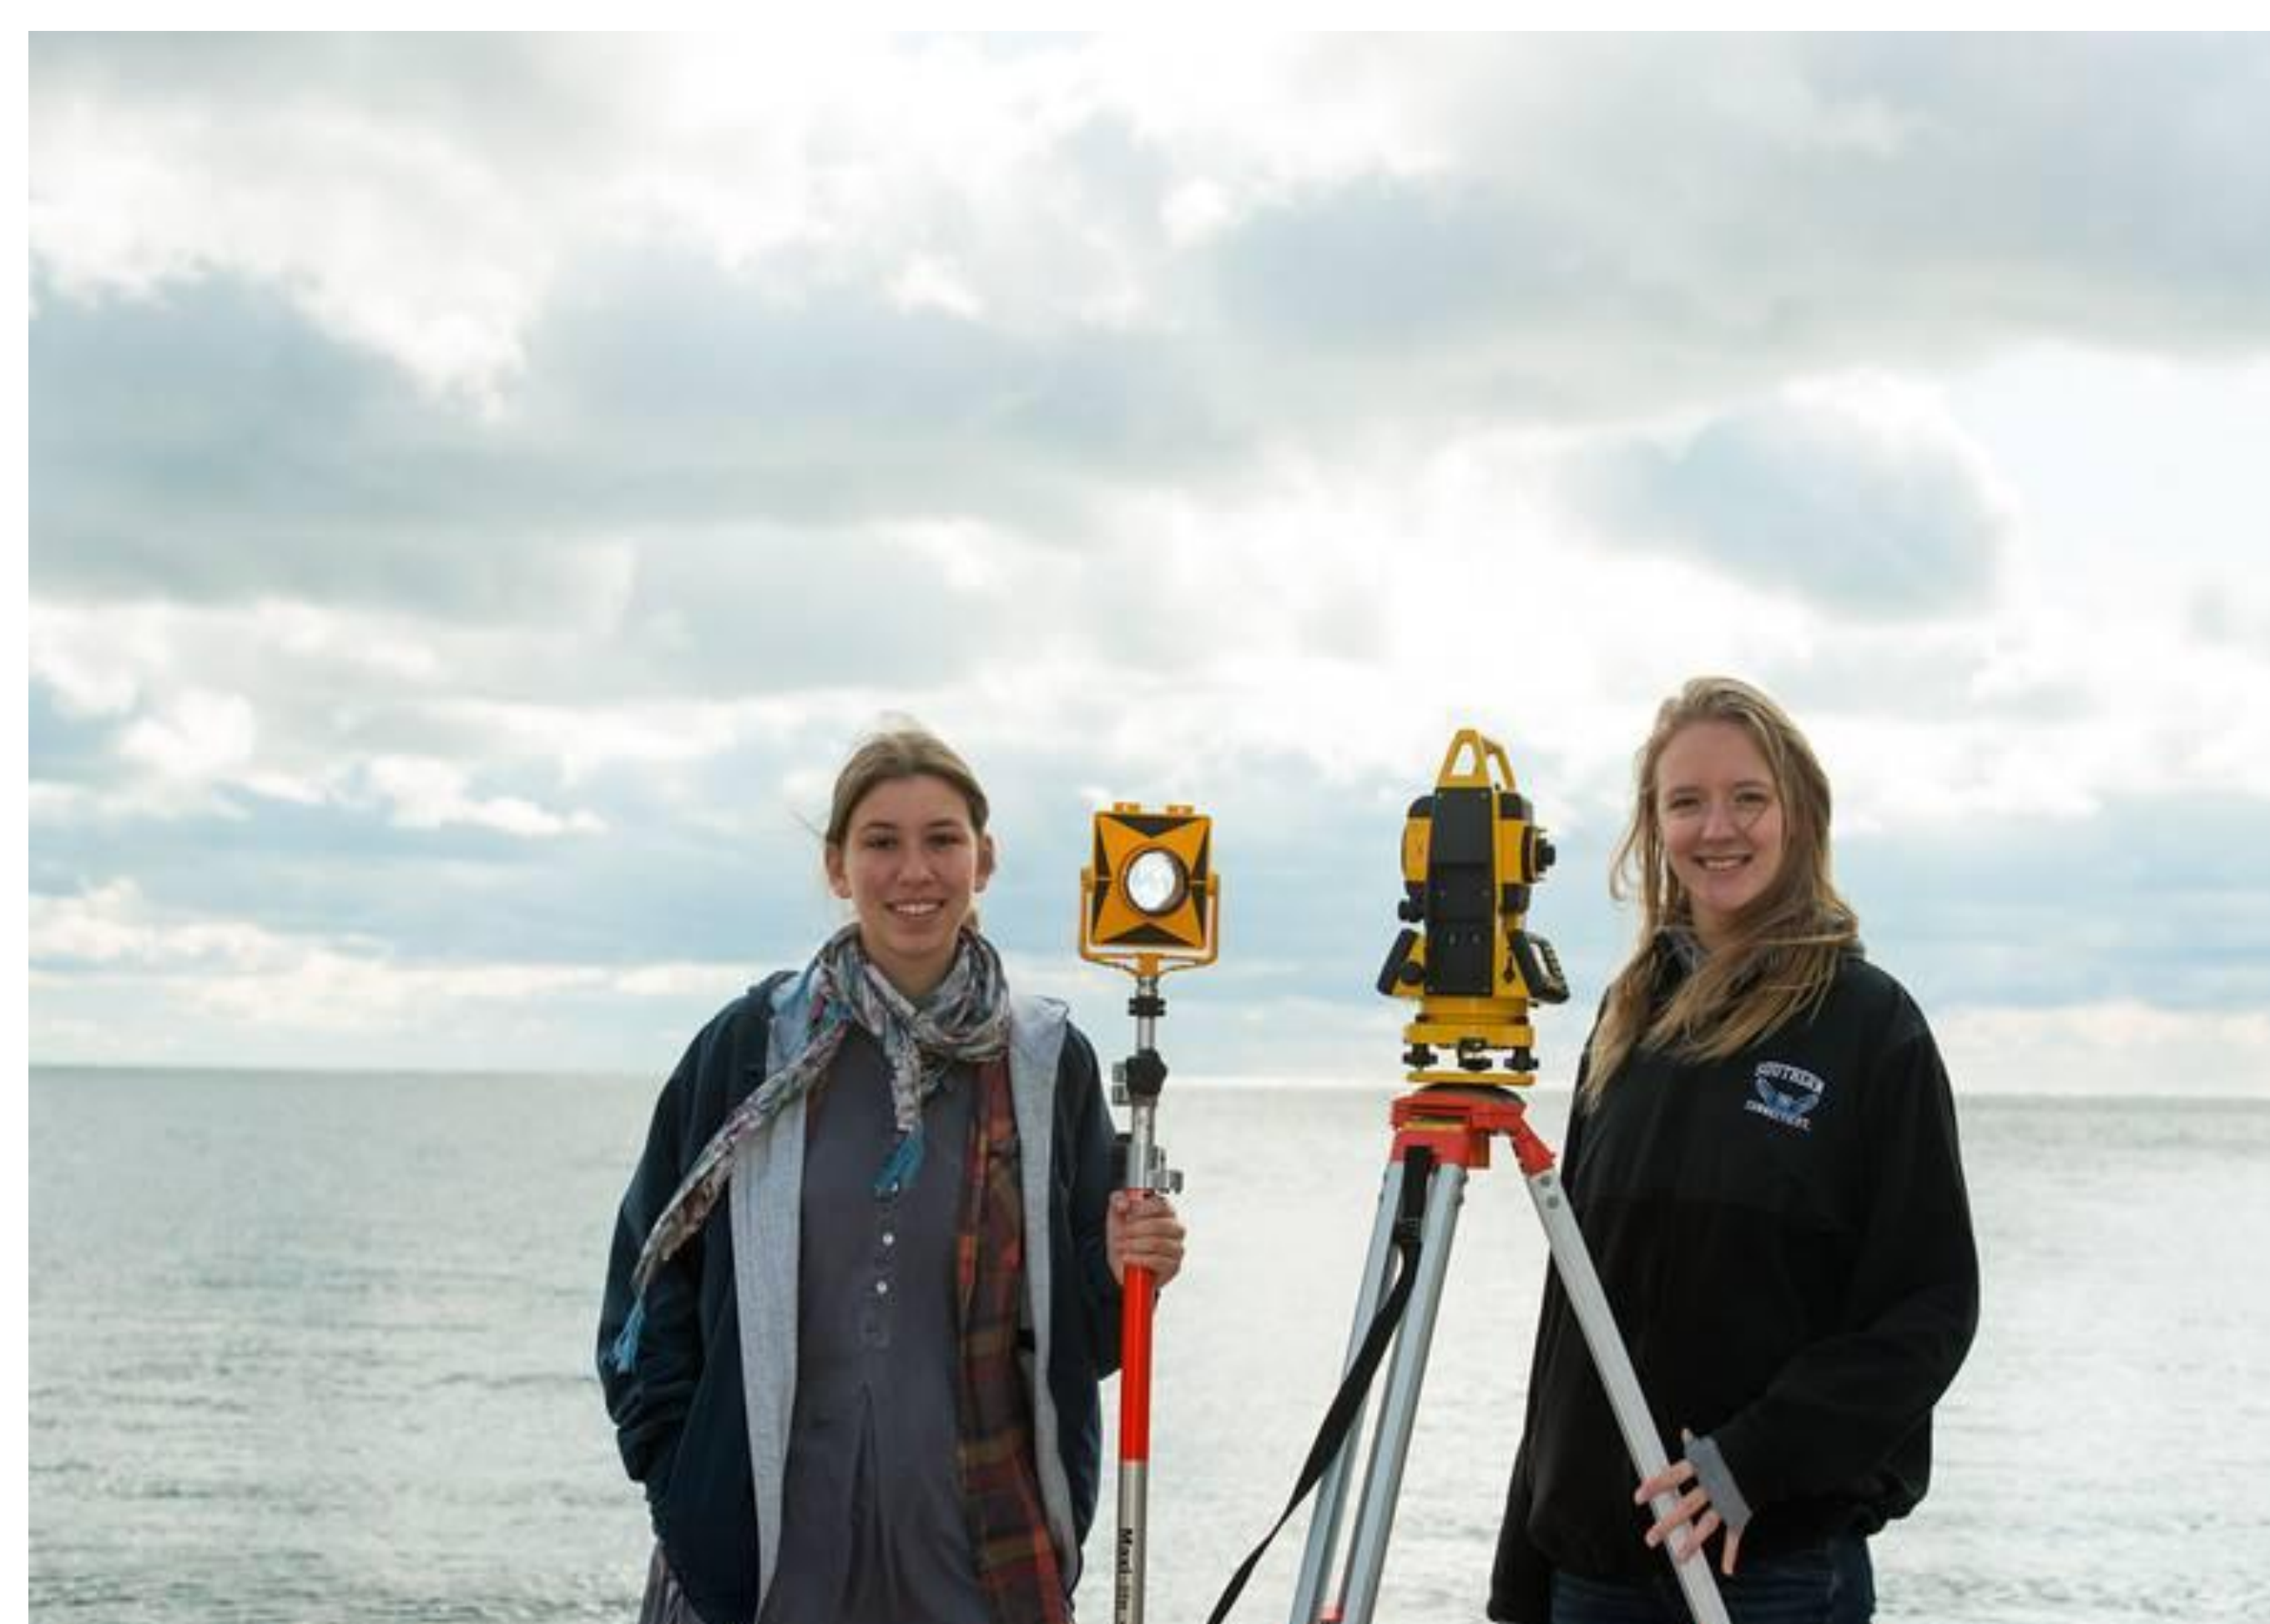
Fatima Cecunjanin and Michelle Ritchie surveying in East Haven, Connecticut.

Following the flooding that accompanied the peak storm surge of Hurricane Sandy, debris lines associated with the flood were located, photographed, and addresses were noted. Successively, blue dots were painted on the spots that represented the debris upper boundaries. Later, these locations were recorded using geographic positioning technology (GPS) and the elevations were measured using laser based surveying technology (total station).

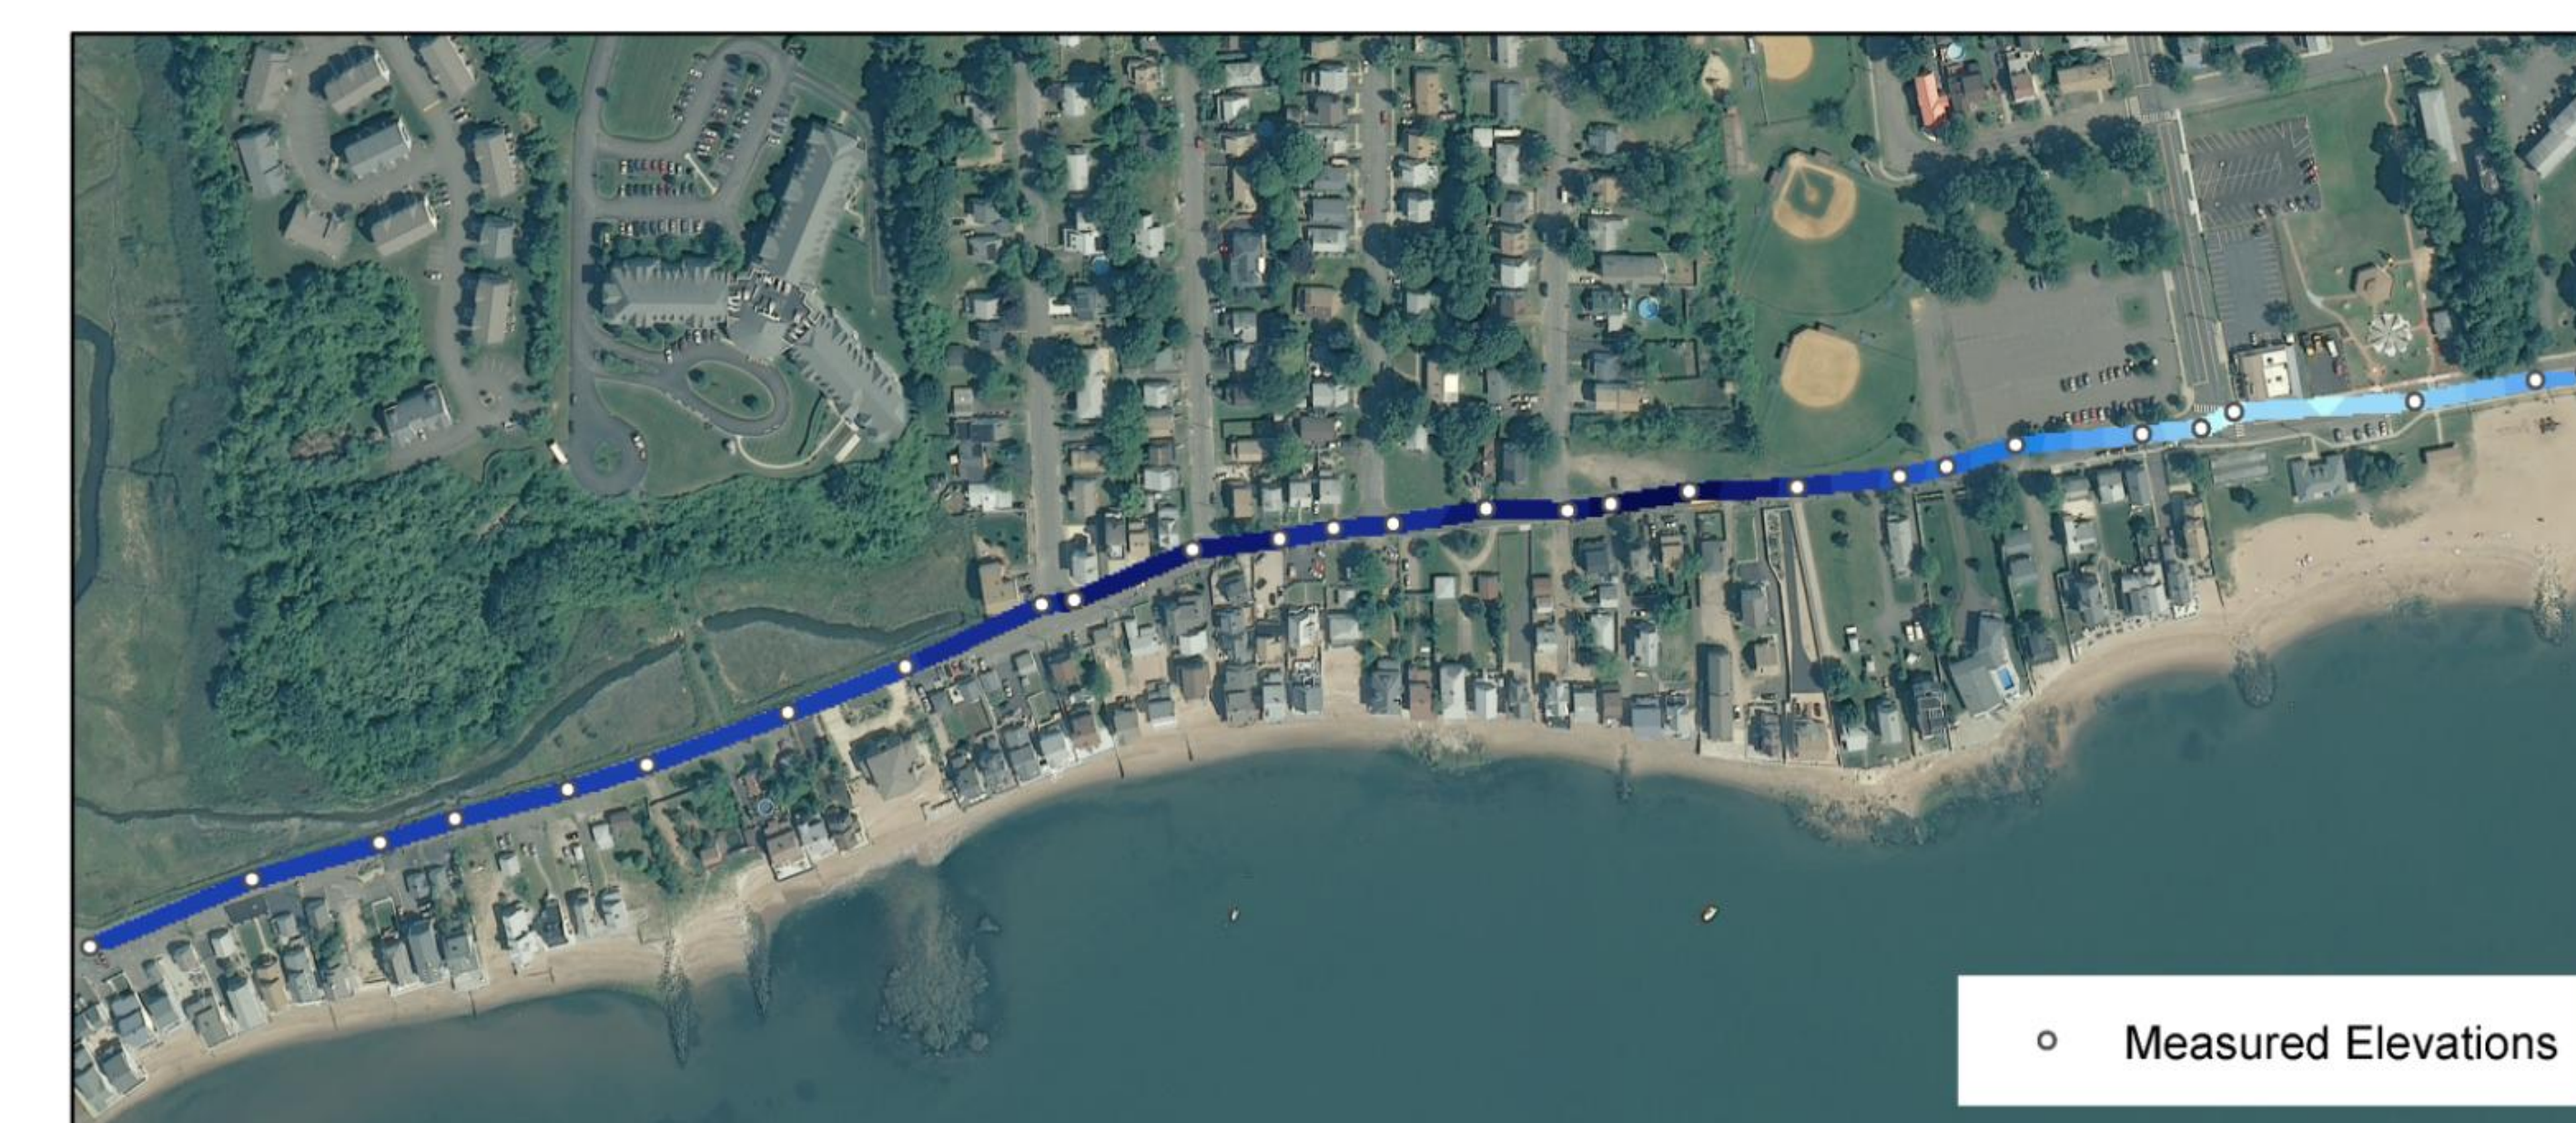
Cozy Beach Avenue, East Haven Road Elevation Relative to MSL

Elevation Data Collected 7/17/14
by Michelle Ritchie and Fatima Cecunjanin

After analyzing wave damage during Sandy, a series of maps were constructed using ESRI's ArcGIS showcasing coastal road elevations, Sandy's peak storm surge, and a series of flood predictions based on the IPCC's sea level rise projections. These maps were then shared with the East Haven town engineers office to aid in updating their emergency response plans. This research also become a part of the town of East Haven's official report to FEMA.

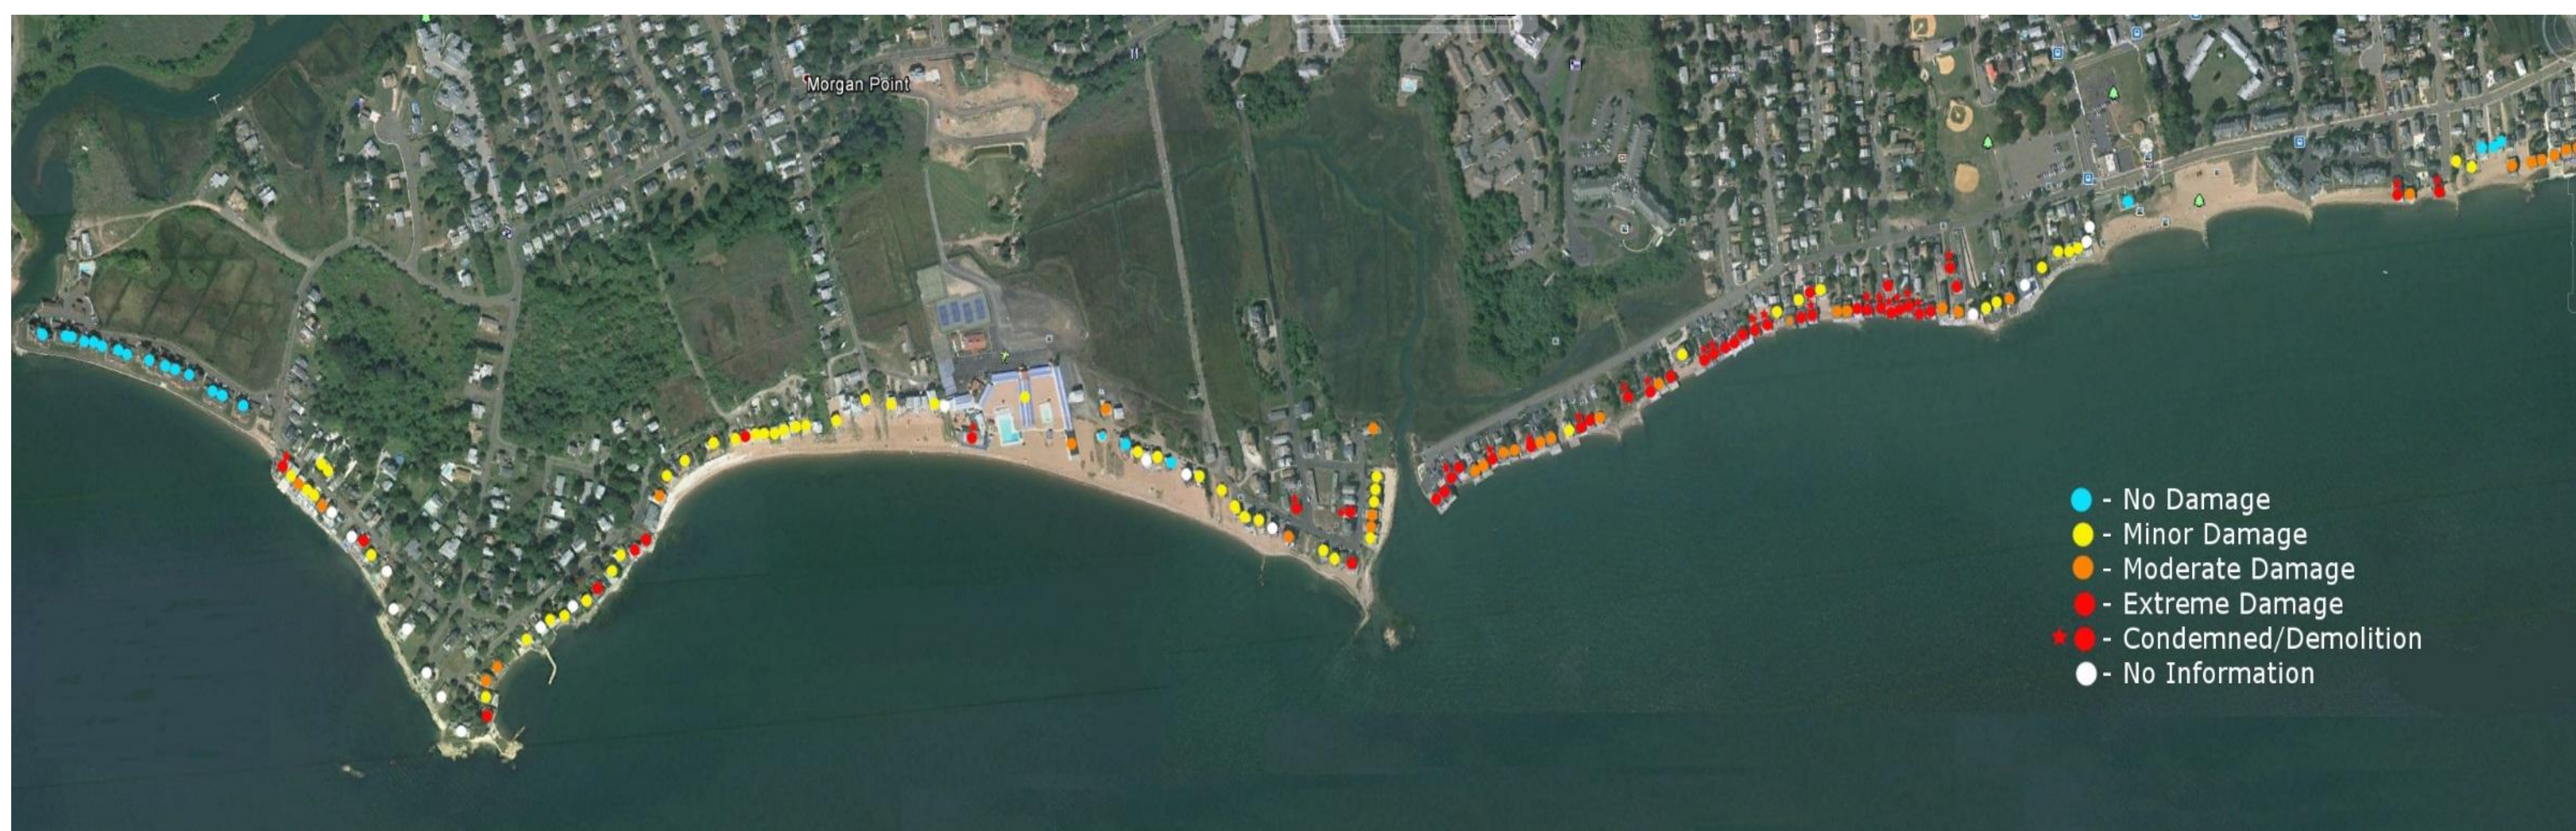
This map illustrates the damages to homes along the East Haven shoreline during Sandy based on interviews conducted by Stephanie Cherry in conjunction with data from town records.
